Debugging a Current Shunt Monitor circuit – Probe Placement and Soldering

TI Precision Labs – Current Sense Amplifiers

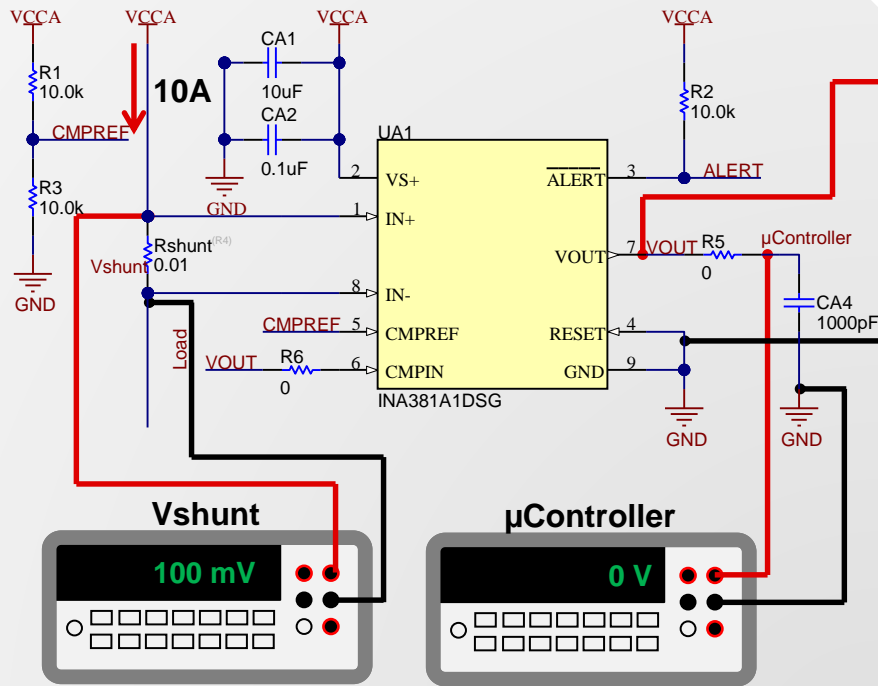
Probe Placement: Case 1

$$\mu\text{Controller}_{\text{expected}} = 100\text{mV} \times 20\frac{\text{V}}{\text{V}} = 2\text{V}$$

To illustrate the impact of probe placement, let's look at the following example here. In this scenario we have a 10A load passing through a 10mΩ shunt. Measuring across the shunt indicates we have 100mV as we expect. Yet when we probe at our microcontroller input test point, which is shorted to VOUT with a 0Ω resistor, we get roughly 0V. Our initial reaction is ughhh our part is broken. However, is this a valid assumption?

Technically we are not probing directly at the device output pin, which is one of the necessary steps for verifying our device is broken. Turns out the output voltage at our pin is 2V as it should be. Closer inspection of our board reveals that R5 is not properly soldered to the board. It should be noted that this was not immediately apparent from an aerial view.

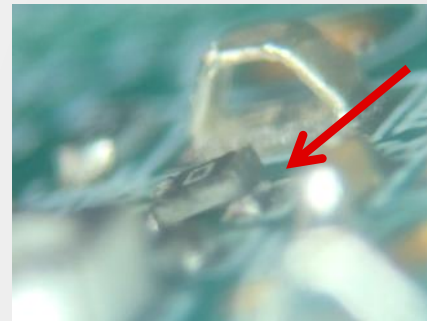
- Solder issue

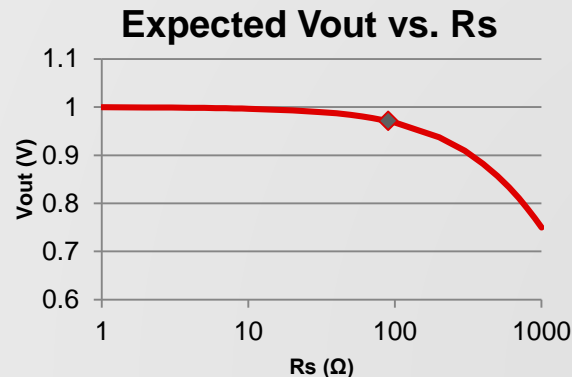
$$V_{\text{os-filter-max}} = \left(100\Omega \times \left(1 + \frac{1\%}{100} \right) \times I_{B+} - 100\Omega \times \left(1 - \frac{1\%}{100} \right) \times I_{B-} \right)$$

$$V_{\text{os-filter-max}} = \left(100\Omega \times \left(1 + \frac{1\%}{100} \right) \times 90\mu\text{A} - 100\Omega \times \left(1 - \frac{1\%}{100} \right) \times 90\mu\text{A} \right)$$

$$V_{\text{os-filter-max}} = 180\mu\text{V}$$

$$V_{\text{os-filter-max}} \times \text{Gain} = 180\mu\text{V} \times 20\frac{\text{V}}{\text{V}} = 3.6\text{mV}$$

Recalling from our layout video that trace symmetry can influence measurement error due to input bias current, we turn back to the schematic and realize that while our traces are symmetric, the filter resistors may not be. The tolerances are 1% on 100Ω resistors. In the extreme case where the resistors have the greatest difference between them, we find the INA240 output could be offset by as much as 3.6mV from the ideal output. While for precision measurements this is significant, it is still almost 10x smaller than the error we are observing, so what else could be our issue? Well we are actually quite close now. Further digging into the datasheet reveals gain error formulas. After putting our filter resistance values into the formula, we see that our output could be as low as 968mV neglecting all other sources of error. It is because of this gain error issue, we typically recommend all filter resistors be no greater than 10Ω for most of our devices. Aside from using small filter resistors with tight tolerances, the key takeaway from this case and the prior case is to probe at multiple points along your signal path starting at the device input and output pins. By doing so you will be able to determine if the signal is reaching the device and thereby discern if the device is indeed broken or you may be able to discover some solder issues.
